## Grade 91: Is it passing the test?

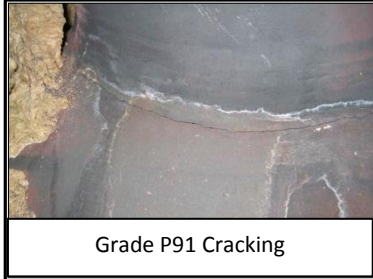
Grade P91 Cracking

Grade P91 materials have properties that differ from traditional low-alloy materials and thus should be handled differently than other low-alloyed steels. Our experience of working closely with P91 has indicated that purchasers, manufacturers, constructors, and plant owners are mishandling the material and therefore damaging the microstructure. Damage to this microstructure may lead to a rapid increase in failures, which should not occur prematurely.

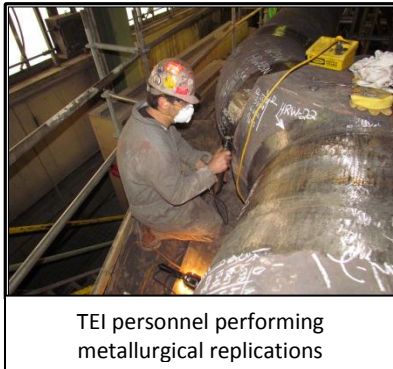
TEI personnel performing metallurgical replications

As part of Thielsch Engineering's metallurgical evaluations, both in-situ metallographic examinations (replications) and/or boat samples may be utilized. These evaluations are performed in order to identify any microstructural changes that may have occurred in the material. In either case, they are examined comprehensively by optical microscopy at magnifications of 100X to 500X. This will provide information about the microstructural condition of the boat samples and identify any service-related deterioration that they may have experienced. Photomicrographs are taken to document the typical conditions observed in the replica foils.

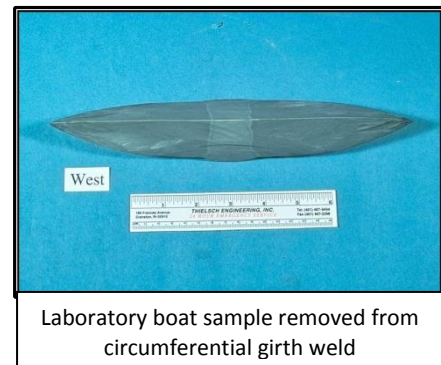
Laboratory boat sample removed from circumferential girth weld

The microstructures are compared with the creep classification developed by EPRI. In addition to this type of testing, boat samples are also analyzed quantitatively by Optical Emission Spectroscopy to determine the chemical composition of the base and weld materials. Finally, boat samples are subjected to stress-rupture testing. It combines the variables of temperature and time to rupture into a single value that can then be used to assess the creep strength of a given sample by comparison with standard curves developed for the particular material of which the sample is composed.
