Thielsch Engineering, Inc.

Pamela Smoske,
Executive Director of
Development and
Operations; 4-SYTE
Systems

PROLONG THE INTEGRITY OF HIGH ENERGY PIPING SYSTEMS: UNIT SPECIFIC STRATEGIC PLANNING

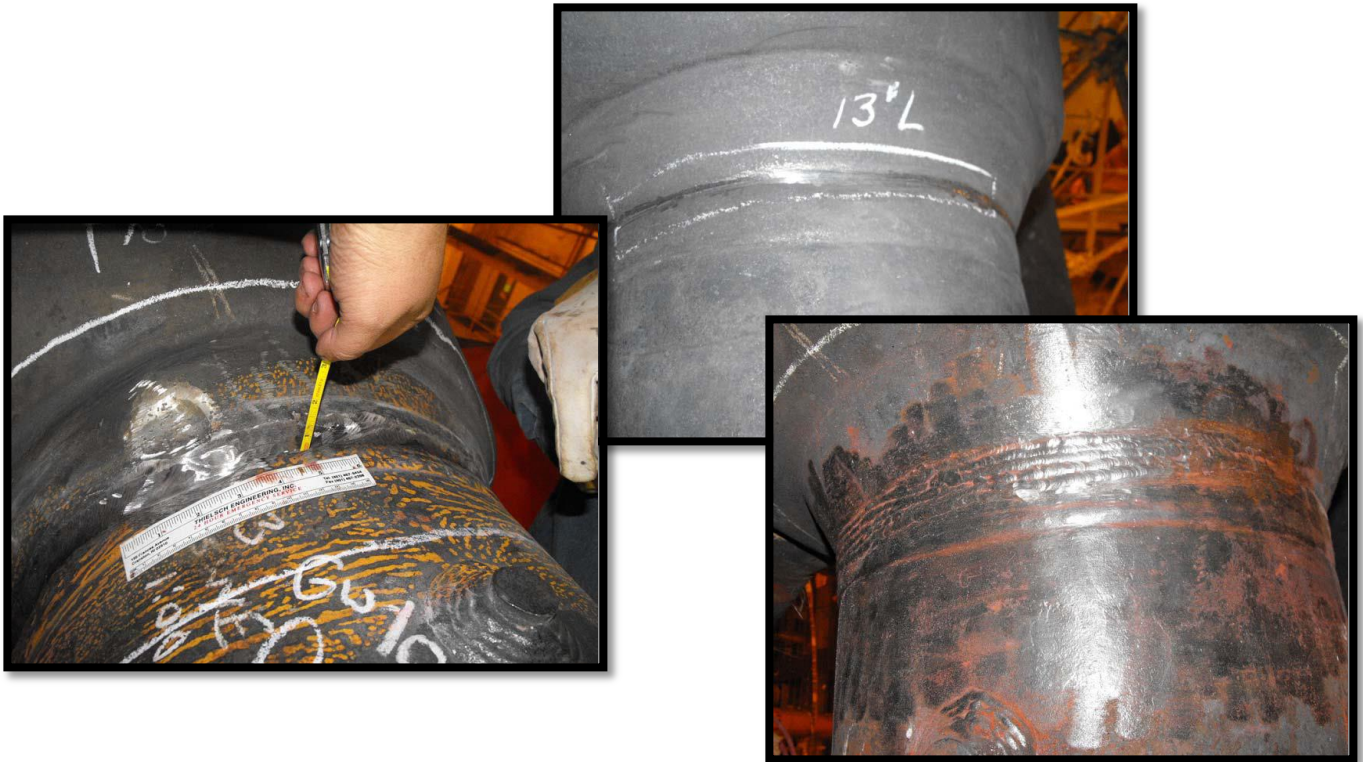
In April of 2010, Thielsch Engineering discovered two significant indications in the girth welds located on the legs of a wye block in the Main Steam piping system of a power station located in the Midwest.

The linear fatigue-type surface indications were discovered during the wet fluorescent magnetic particle examination. The first indication was 13" long, at the 12:00 o'clock in the toe of the weld on the north wye block. The second indication was 4" long at the 12:00 o'clock position, in the

toe of the weld on the same wye block. These indications were evaluated and confirmed to require repairs.

Thielsch Engineering was contracted to provide guidance and supervision to supply a weld repair program, and to perform repairs by welding on the Main Steam piping system, thus returning the

piping to a level of integrity suitable for continued service under design operating conditions. After conducting a thorough examination of the piping system, it was revealed that several hangers upstream and downstream of this weld were either damaged or bottomed out resulting in insufficient piping support and movement. A full hot and cold condition hanger walkdown and pipe stress analyses were recommended to bring the unit back to a suitable condition for continued safe and reliable operation.

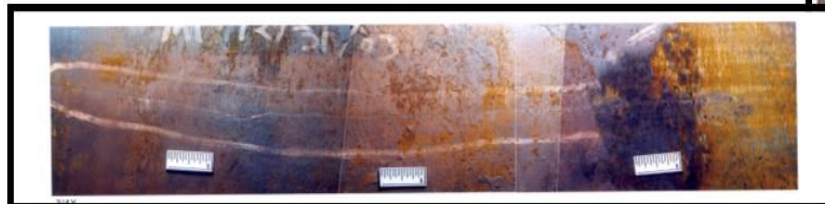
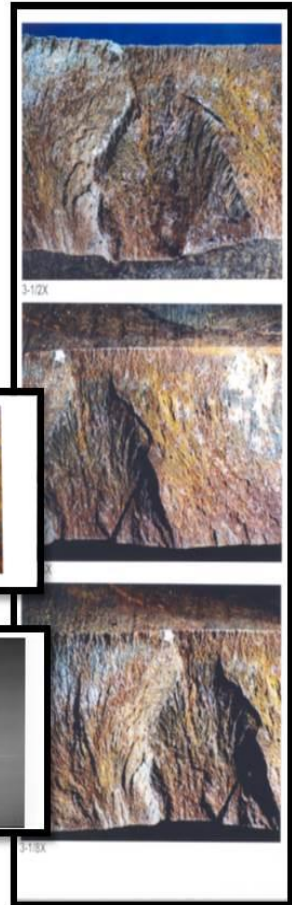
The results of the metallurgical evaluation confirmed that the pipe segment had been subject to localized overheating. The localized overheating was sufficiently severe to result in reaustenitization, grain growth and cracking. The cracking and microstructural transformations introduced during the localized overheating rendered the pipe subject to brittle failure during subsequent handling.

The defect present in this pipe segment represents a localized condition. On the opposite side of the pipe segment, the microstructure and tensile properties were typical for pipe produced in accordance with ASTM Specification A-335, Grade P91. The source of the localized overheating could not be identified definitively from the results of the metallurgical evaluation. It is known, however, that the overheating occurred prior to the radiographic examination and postweld heat treatment of the affected field weld. Possible sources of localized overheating include the tempering heat treatment performed during original manufacture of the pipe, postweld heat treatment performed during fabrication of the spool piece of which this pipe was part, or some undocumented event.

In January of 2004, General Electric Power Systems (GE) submitted a pipe segment to Thielsch Engineering. This pipe segment had been removed from a Hot Reheat piping system from a facility in Pennsylvania. It contained a through-wall crack that resulted in a leak during hydrostatic testing of the piping system. Thielsch Engineering was requested to perform a detailed metallurgical evaluation of the pipe segment to determine the cause of the crack.

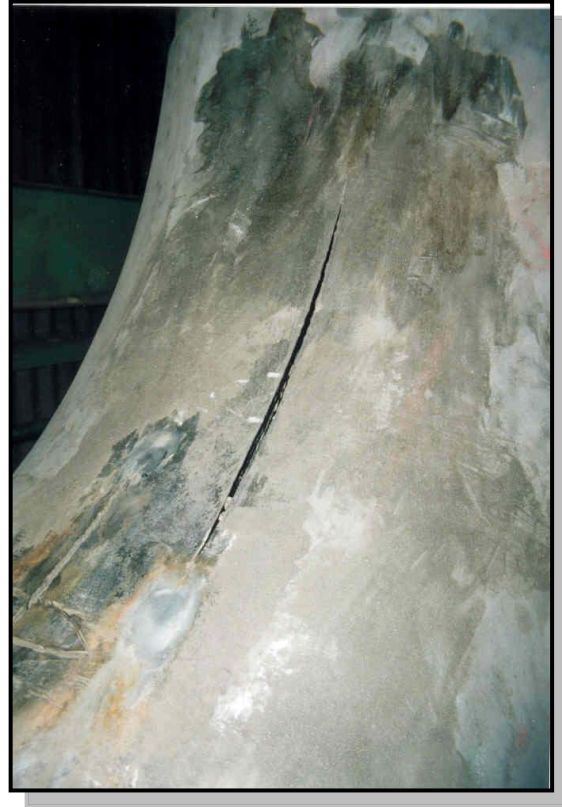
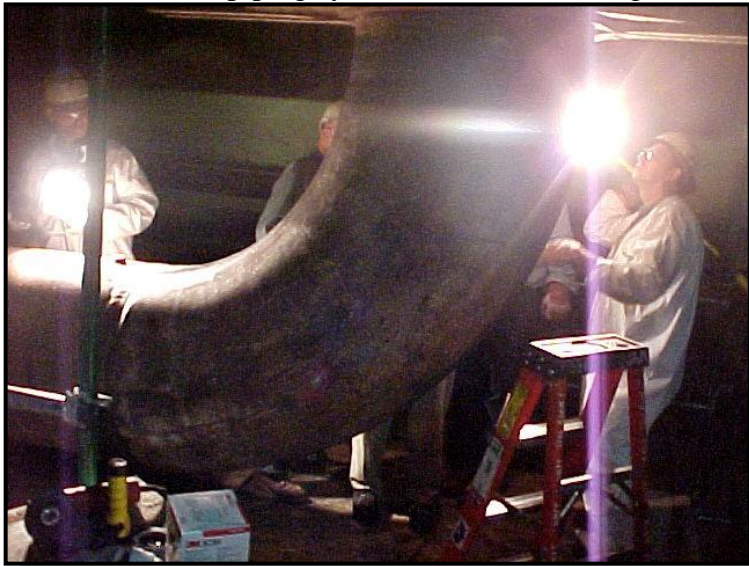
In May of 2002, a leak occurred in a Main Steam piping system at a facility located in the Midwest. This leak was the result of through-wall cracking that developed in the intrados of a clamshell elbow. Thielsch Engineering performed a metallurgical evaluation of two boat samples removed from this elbow to determine the cause of the cracking. The results of this metallurgical evaluation confirmed that the cracking in these boat samples was caused by fatigue acting in conjunction with creep. The cracking is the result of an applied bending stress. (The condition of the elbow, which had been welded with a low carbon filler material, contained at least one original weld defect, and had been heavily ground subsequent to welding, rendered it susceptible to failure by fatigue and/or creep.)

This piping system was designed and erected in accordance with the requirements of the ANSI (now ASME) 831.1 Code on Pressure Piping covering "Power Piping". The Main Steam piping system was designed to withstand a pressure of 2,650 psig at a temperature of 1015°F. (The operating conditions for this piping system involve a pressure of 2,400 psig at a temperature of 1000°F.)

The Main Steam piping system was erected using low-alloy steel pipe and fittings. The pipe was produced to the requirements of ASTM Specification A-335 covering "Seamless Ferritic Alloy Steel Pipe for High-Temperature Service". It involved Grade P22, a low-alloy steel material with a nominal composition of 2-1/4% chromium and 1% molybdenum, i.e., a 2-1/4 Cr- 1 Mo low-alloy steel. The fittings were produced to the requirements of ASTM Specification A-217, Grade WC9 covering "Alloy Steel Castings for Pressure-Containing Parts Suitable for High-Temperature Service".

Thielsch Engineering developed and instituted a repair welding program to address the cracking that had developed in the intrados of the elbow. This program, which complied with the requirements of all applicable Codes has restored the replacement elbow to a level of integrity suitable for continued service for at least five additional years.
